**DOT/FAA/TC-22/35**

# **Small Unmanned Aircraft System for Pavement Inspection: Task 4—Execute the Field Demonstration Plan and Analyze the Collected Data**

November 2022

Final Report

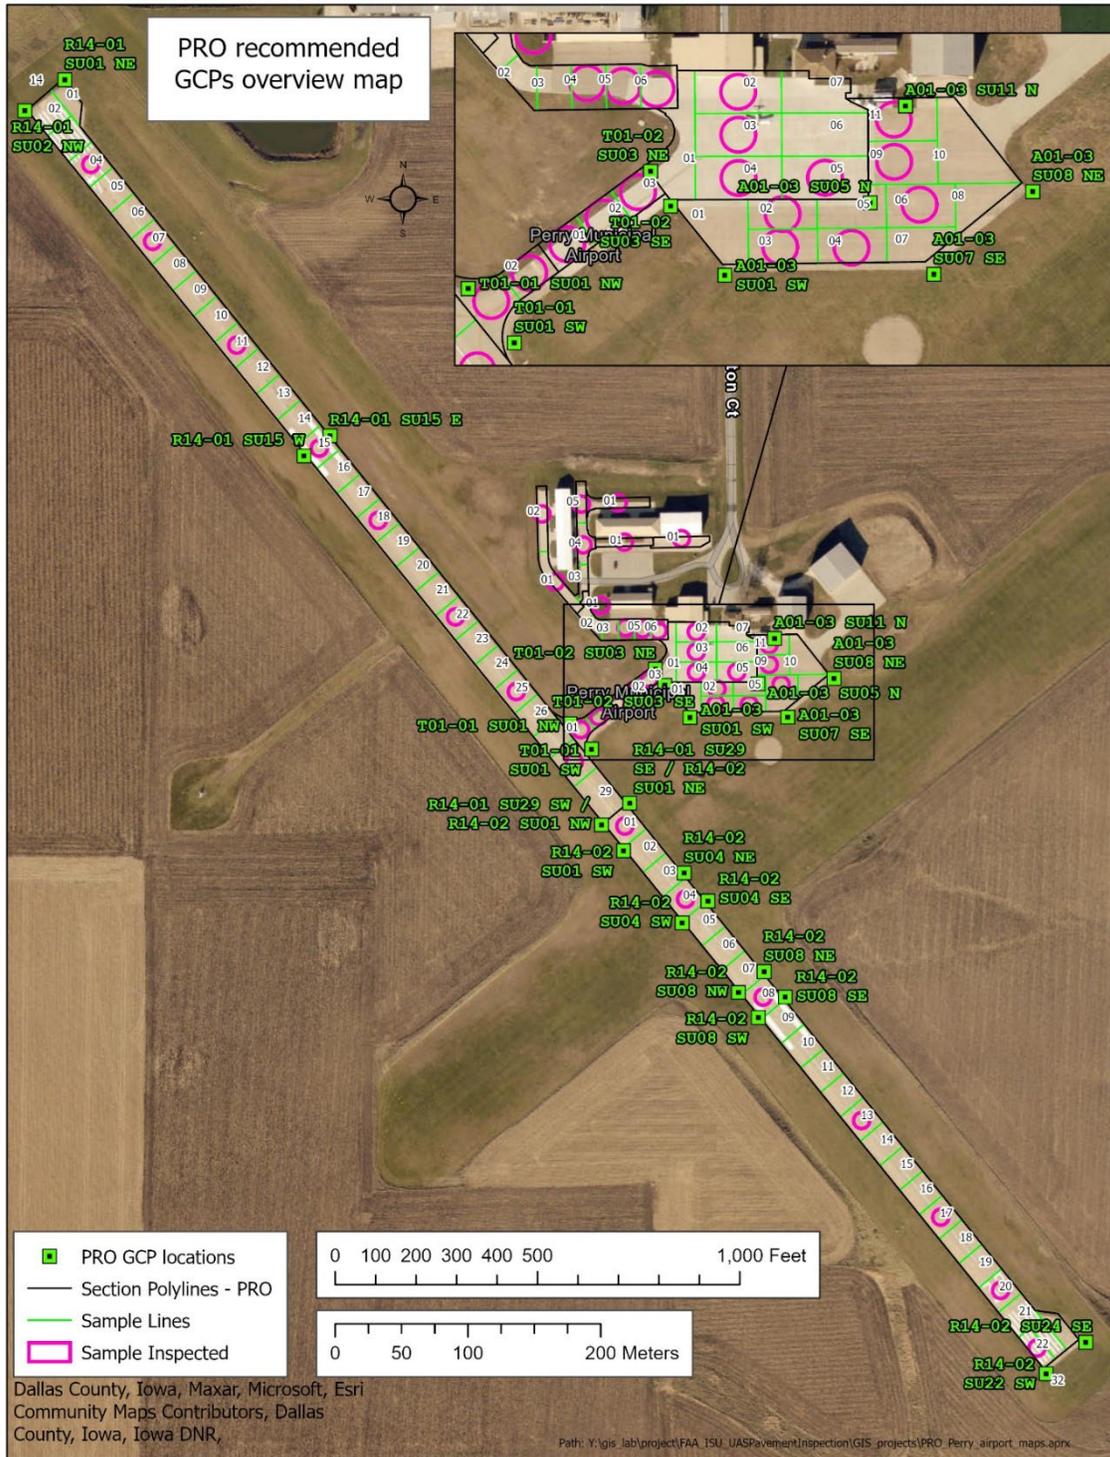
Figure 50. Recommended Locations for GCPs at PRO

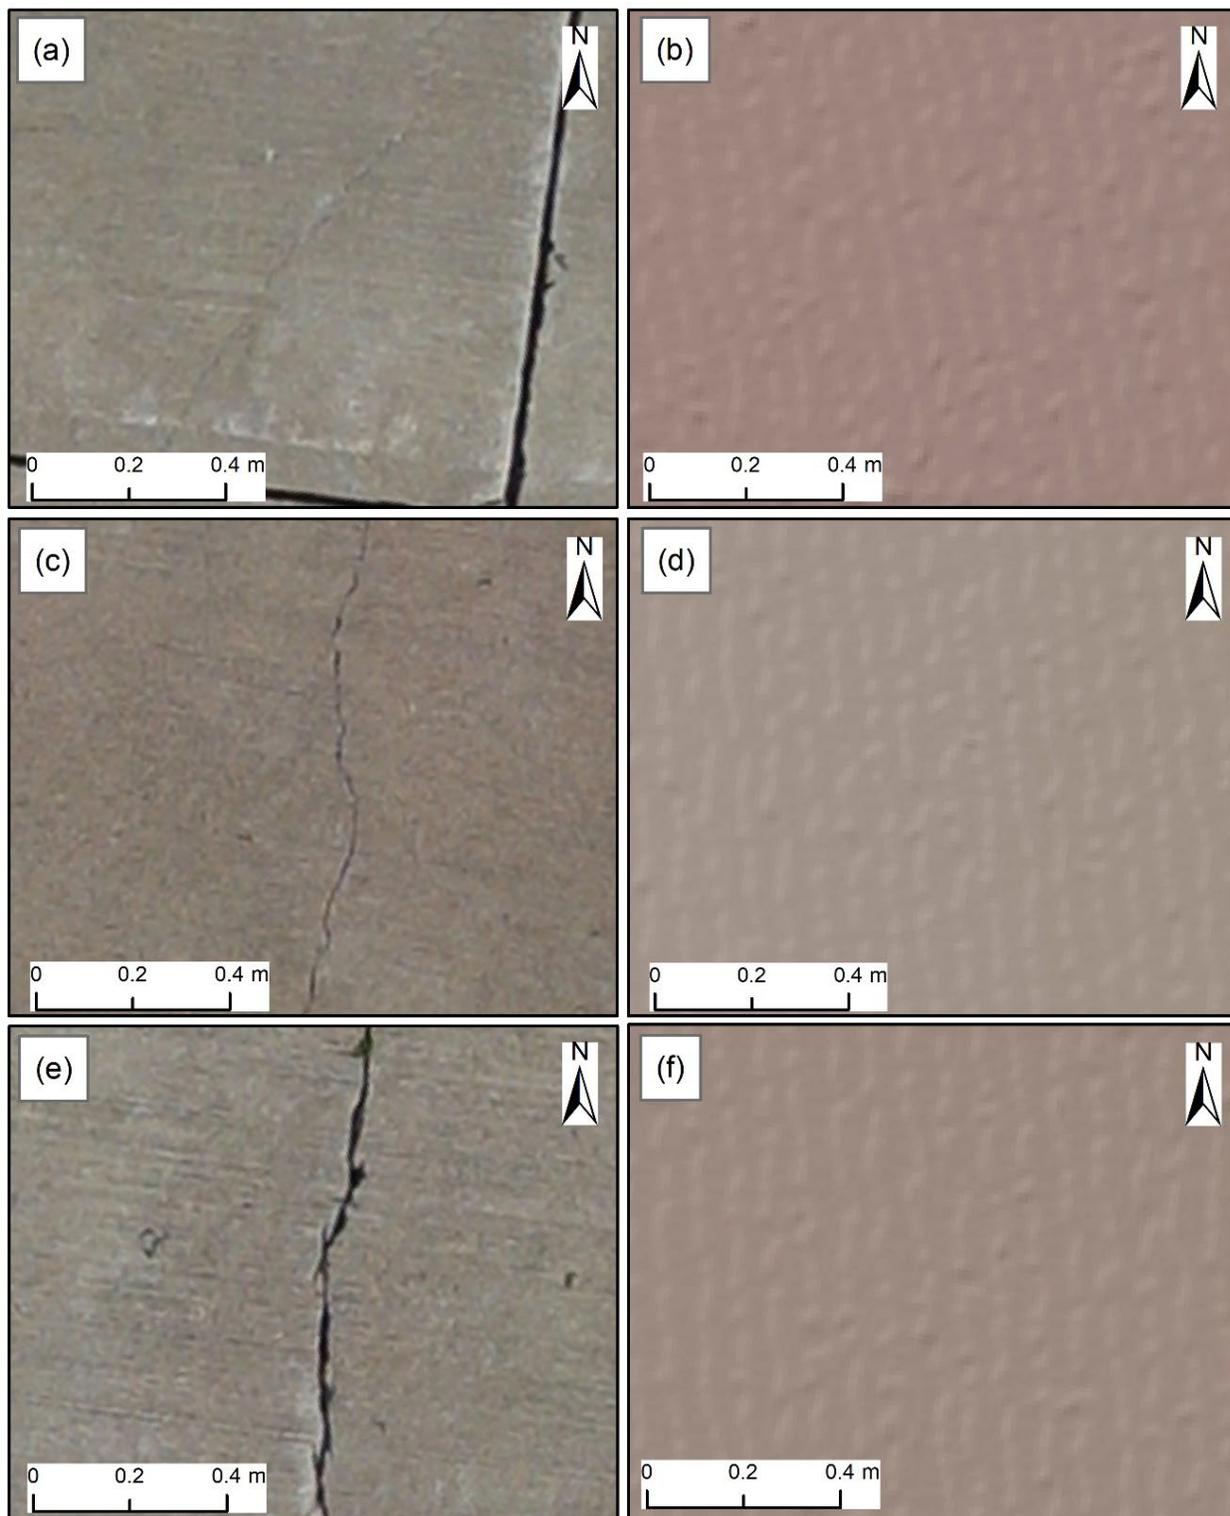
Figure 52. Low-severity Corner Break in (a) 2.5-mm/pix Orthophoto and (b) 10-mm/pix DEM;  
 Low-severity LTD Cracks in (c) 2.5-mm/pix Orthophoto, (d) 10-mm/pix DEM;  
 and Medium-severity LTD Cracks in 2.5-mm/pix Orthophoto and (f) 10 mm/pix DEM

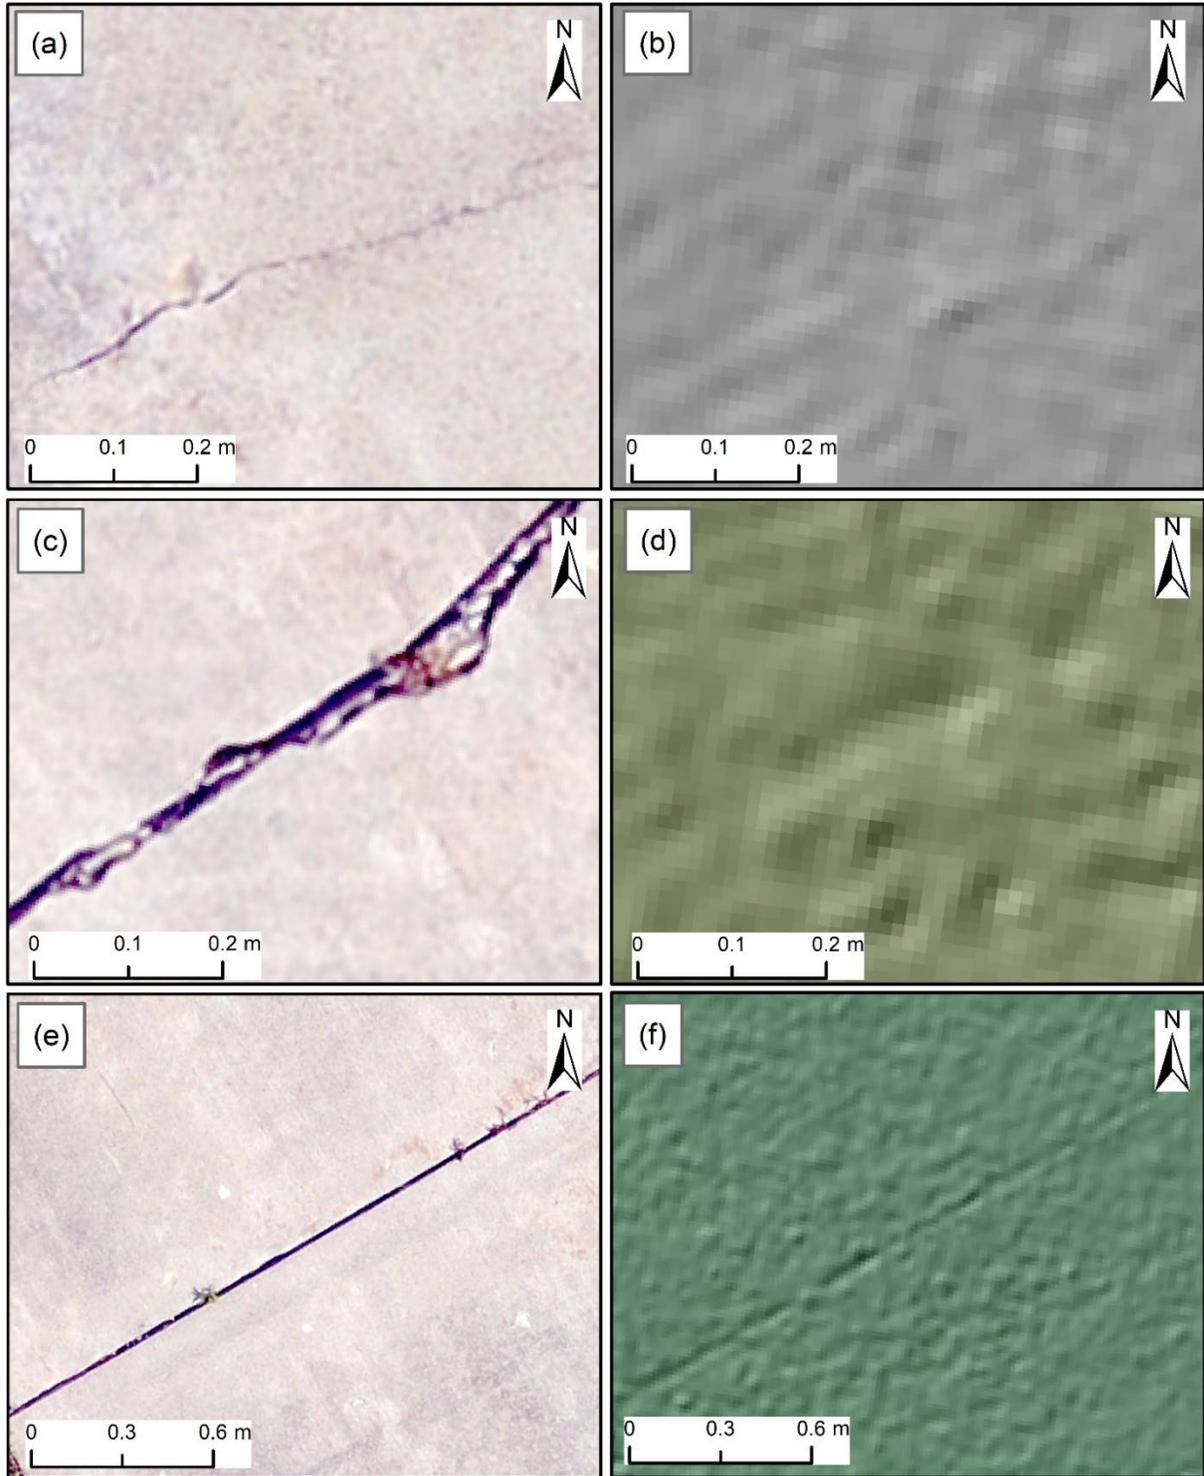
Figure 53. Low-severity LTD Cracks in (a) 3.2-mm/pix Orthophoto and (b) 12.9-mm/pix DEM; Medium-severity LTD Cracks in (c) 3.2-mm/pix Orthophoto and (d) 12.9-mm/pix DEM; and High-severity Joint Seal Damage in (e) 3.2-mm/pix Orthophoto and (f) 12.9-mm/pix DEM

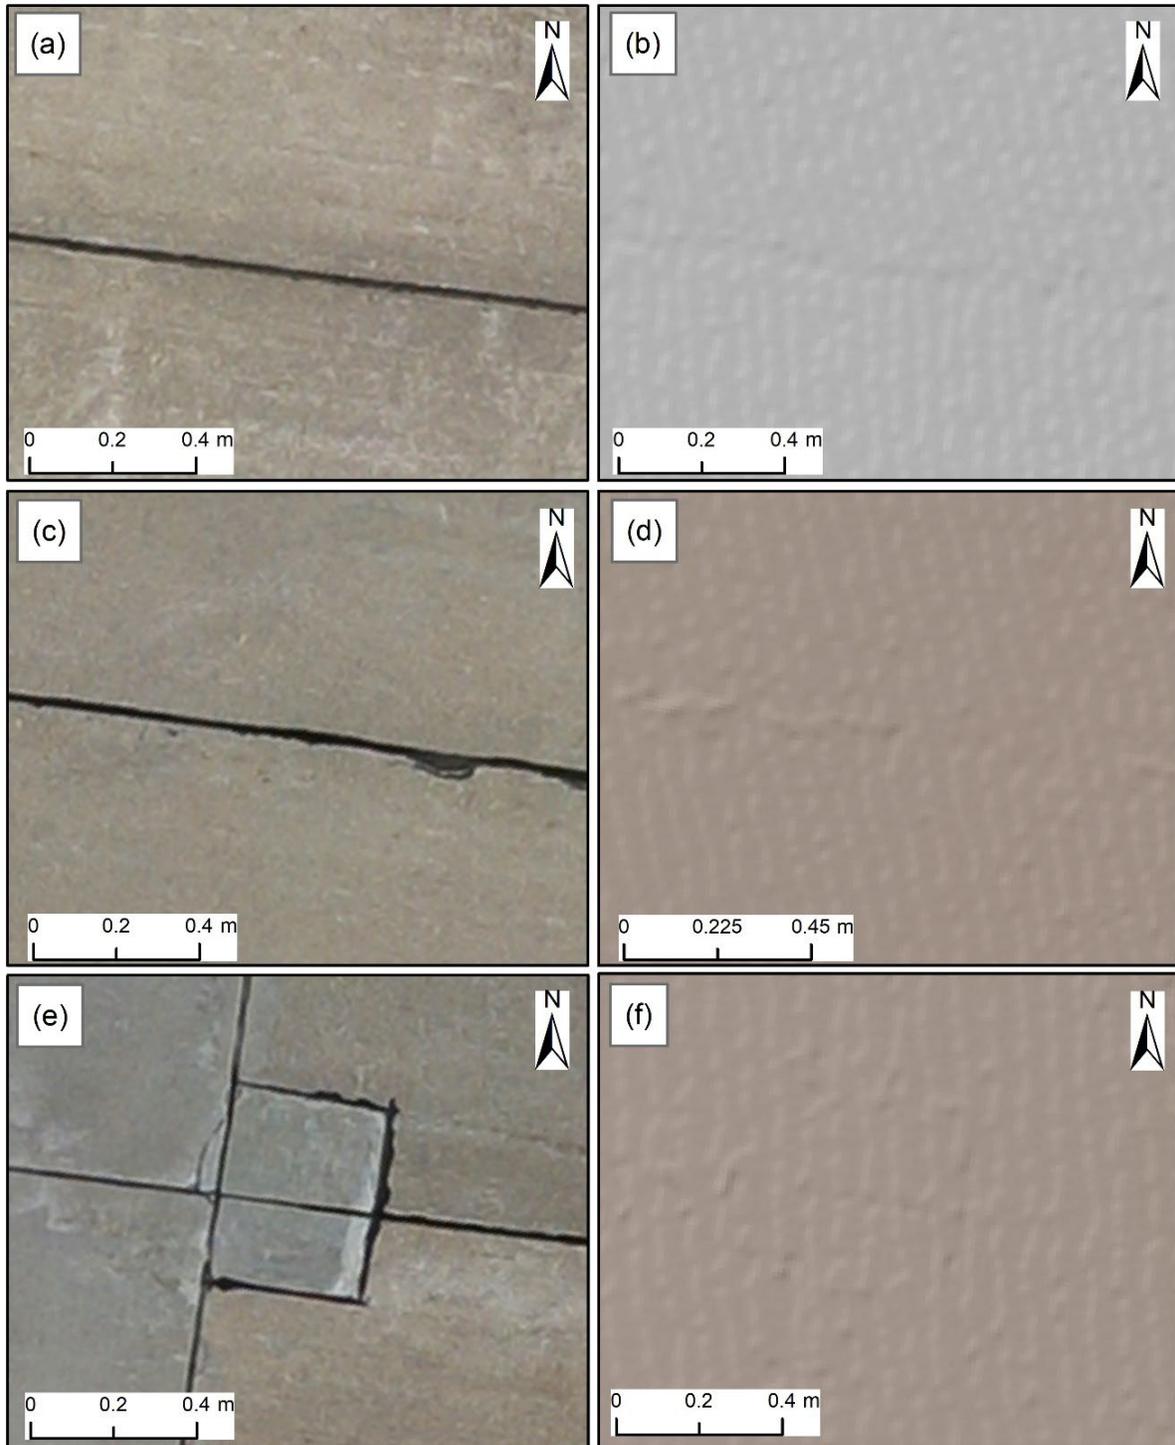
Figure 54. Low-severity Joint Seal Damage in (a) 2.5-mm/pix Orthophoto and (b) 10-mm/pix DEM; Medium-severity Joint Seal Damage in (c) 2.5-mm/pix Orthophoto and (d) 10-mm/pix DEM; and Low-severity Small Patching in (e) 2.5-mm/pix Orthophoto and (f) 10-mm/pix DEM

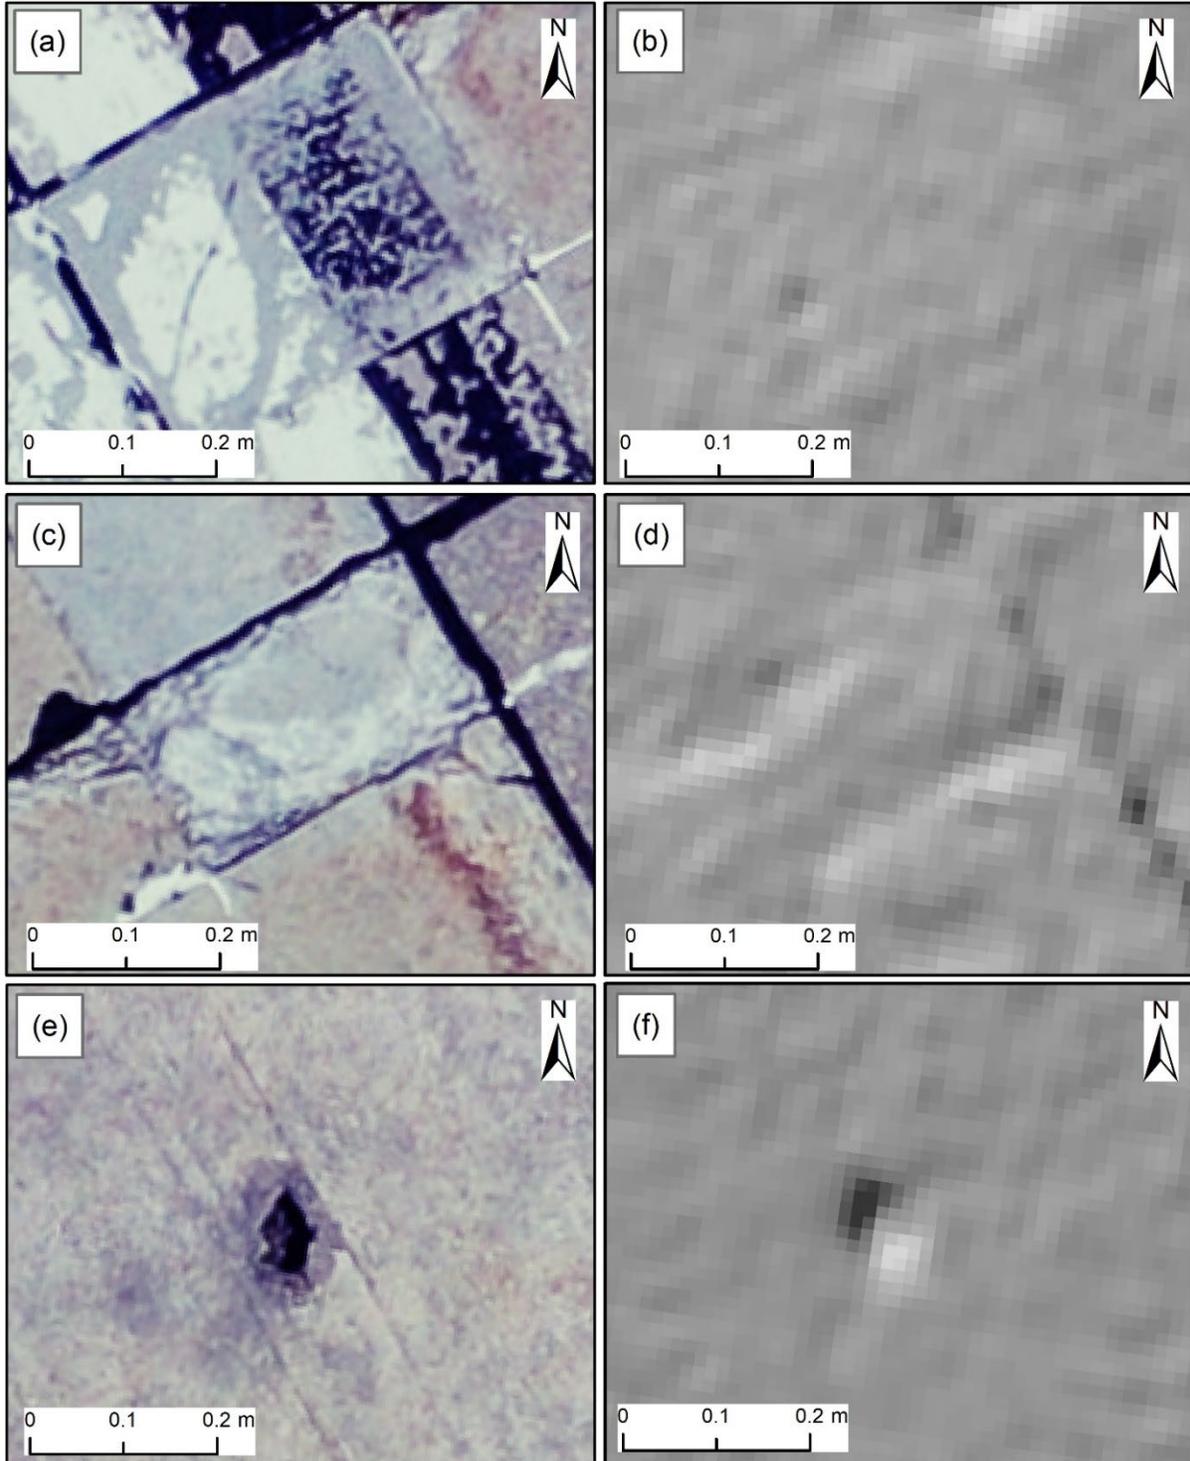
Figure 55. Low-severity Small Patching in (a) 3.2-mm/pix orthophoto and (b) 12.9-mm/pix DEM; Medium-severity Small Patching in (c) 3.2-mm/pix Orthophoto and (d) 12.9-mm/pix DEM; and High-severity Small Patching in (e) 3.2-mm/pix Orthophoto and (f) 12.9-mm/pix DEM

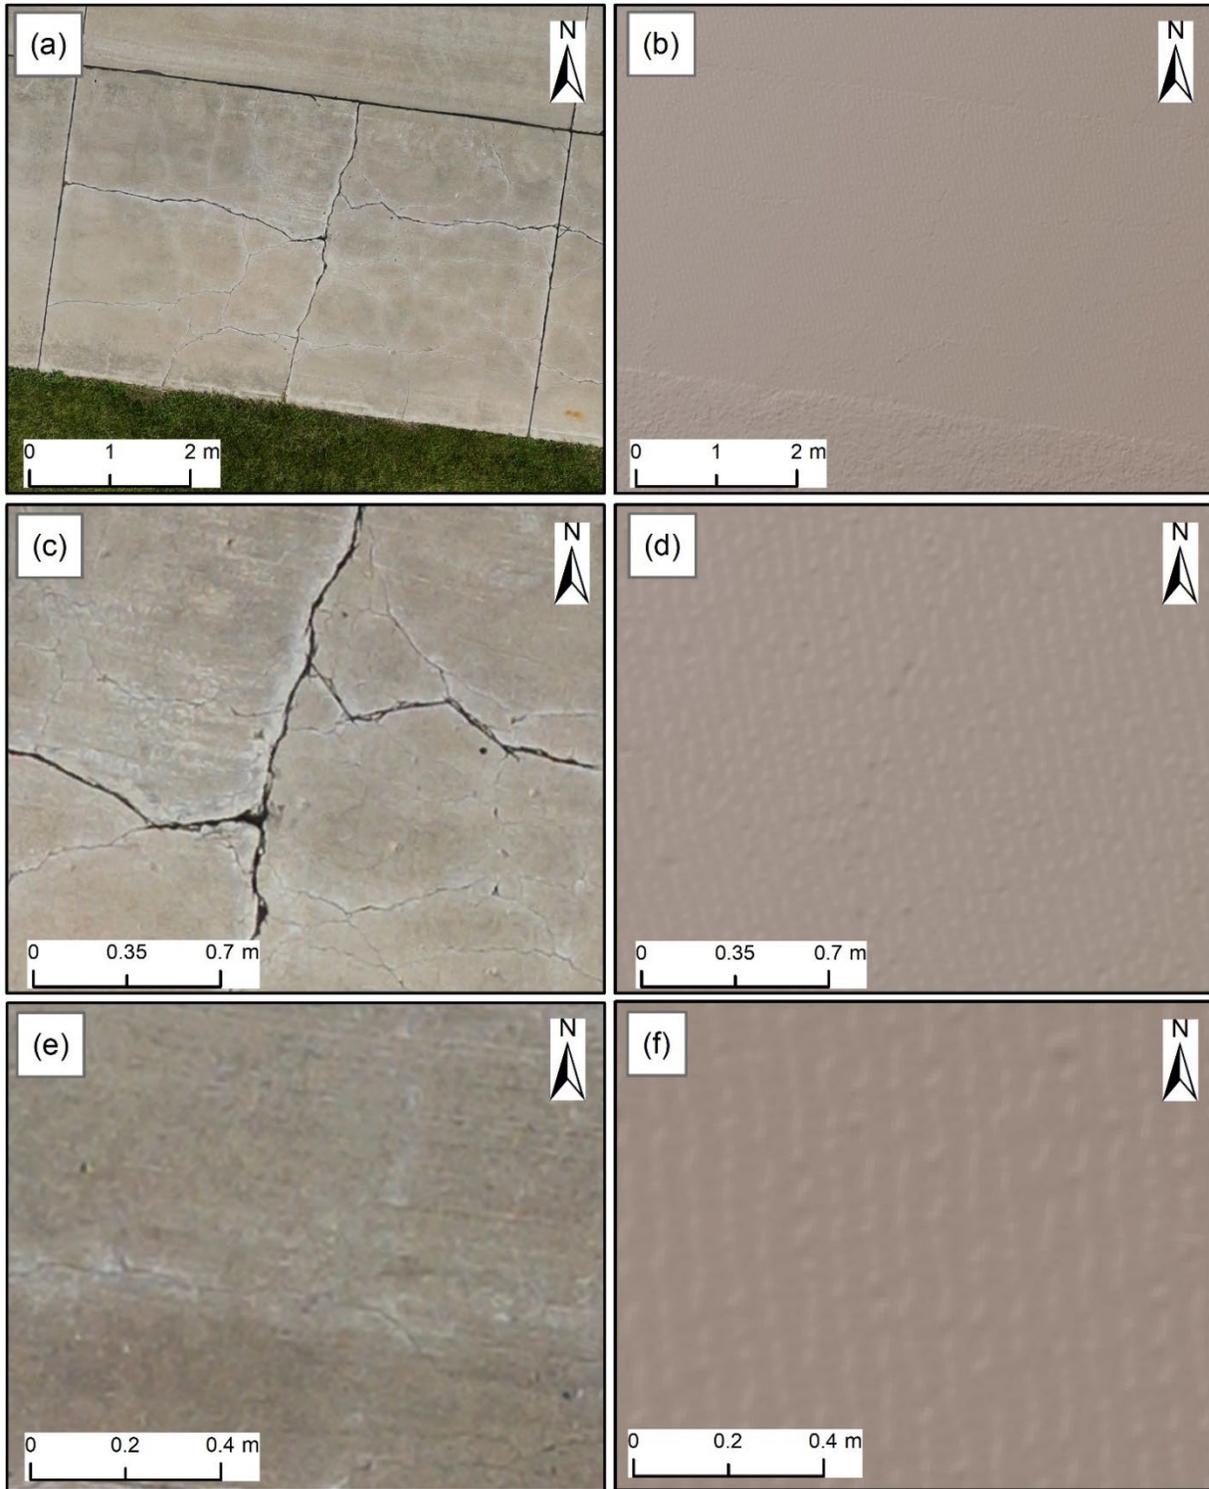
Figure 58. High-severity Shattered Slab in (a, c) 2.5-mm/pix Orthophoto and (b, d) 10-mm/pix DEM and Shrinkage Crack in (e) 2.5-mm/pix Orthophoto and (f) 10-mm/pix DEM

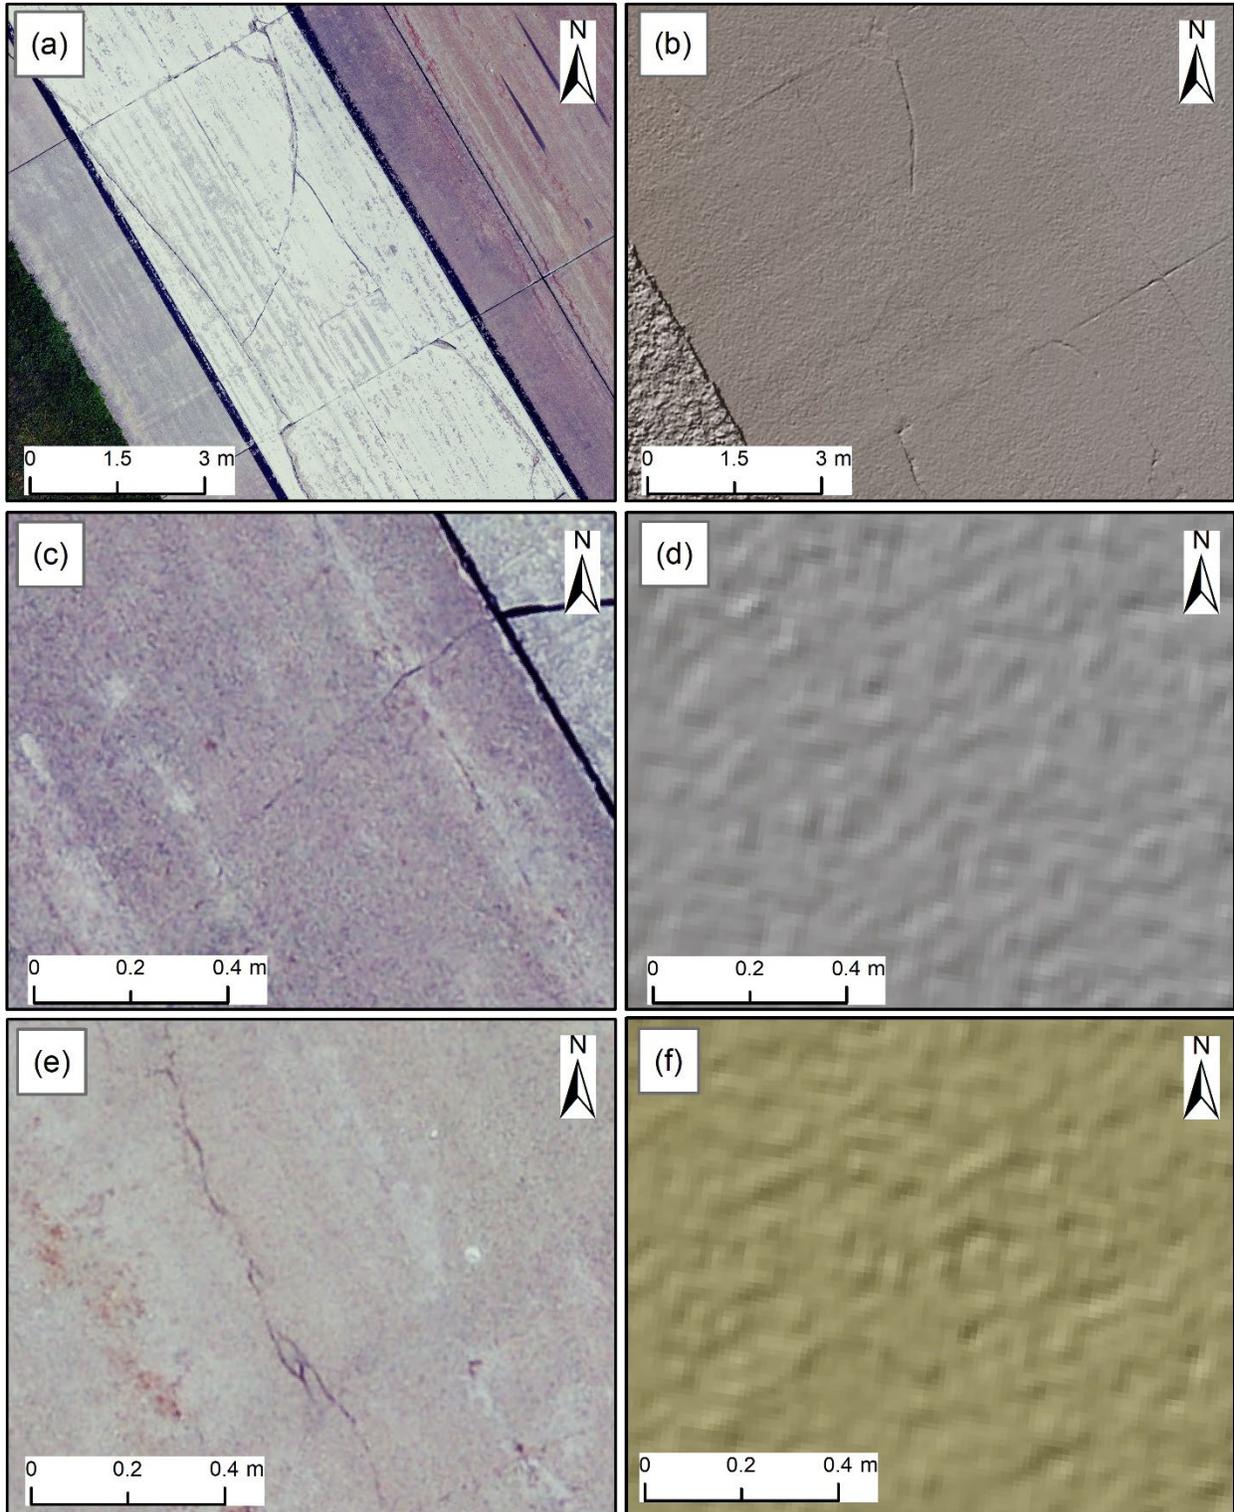
Figure 59. Medium-severity Shattered Slab in (a) 3.2-mm/pix Orthophoto and (b) 12.9-mm/pix DEM; Shrinkage Crack (c) 3.2-mm/pix Orthophoto and (d) 12.9-mm/pix DEM; and Low-severity ASR in (e) 3.2-mm/pix Orthophoto and (f) 12.9-mm/pix DEM

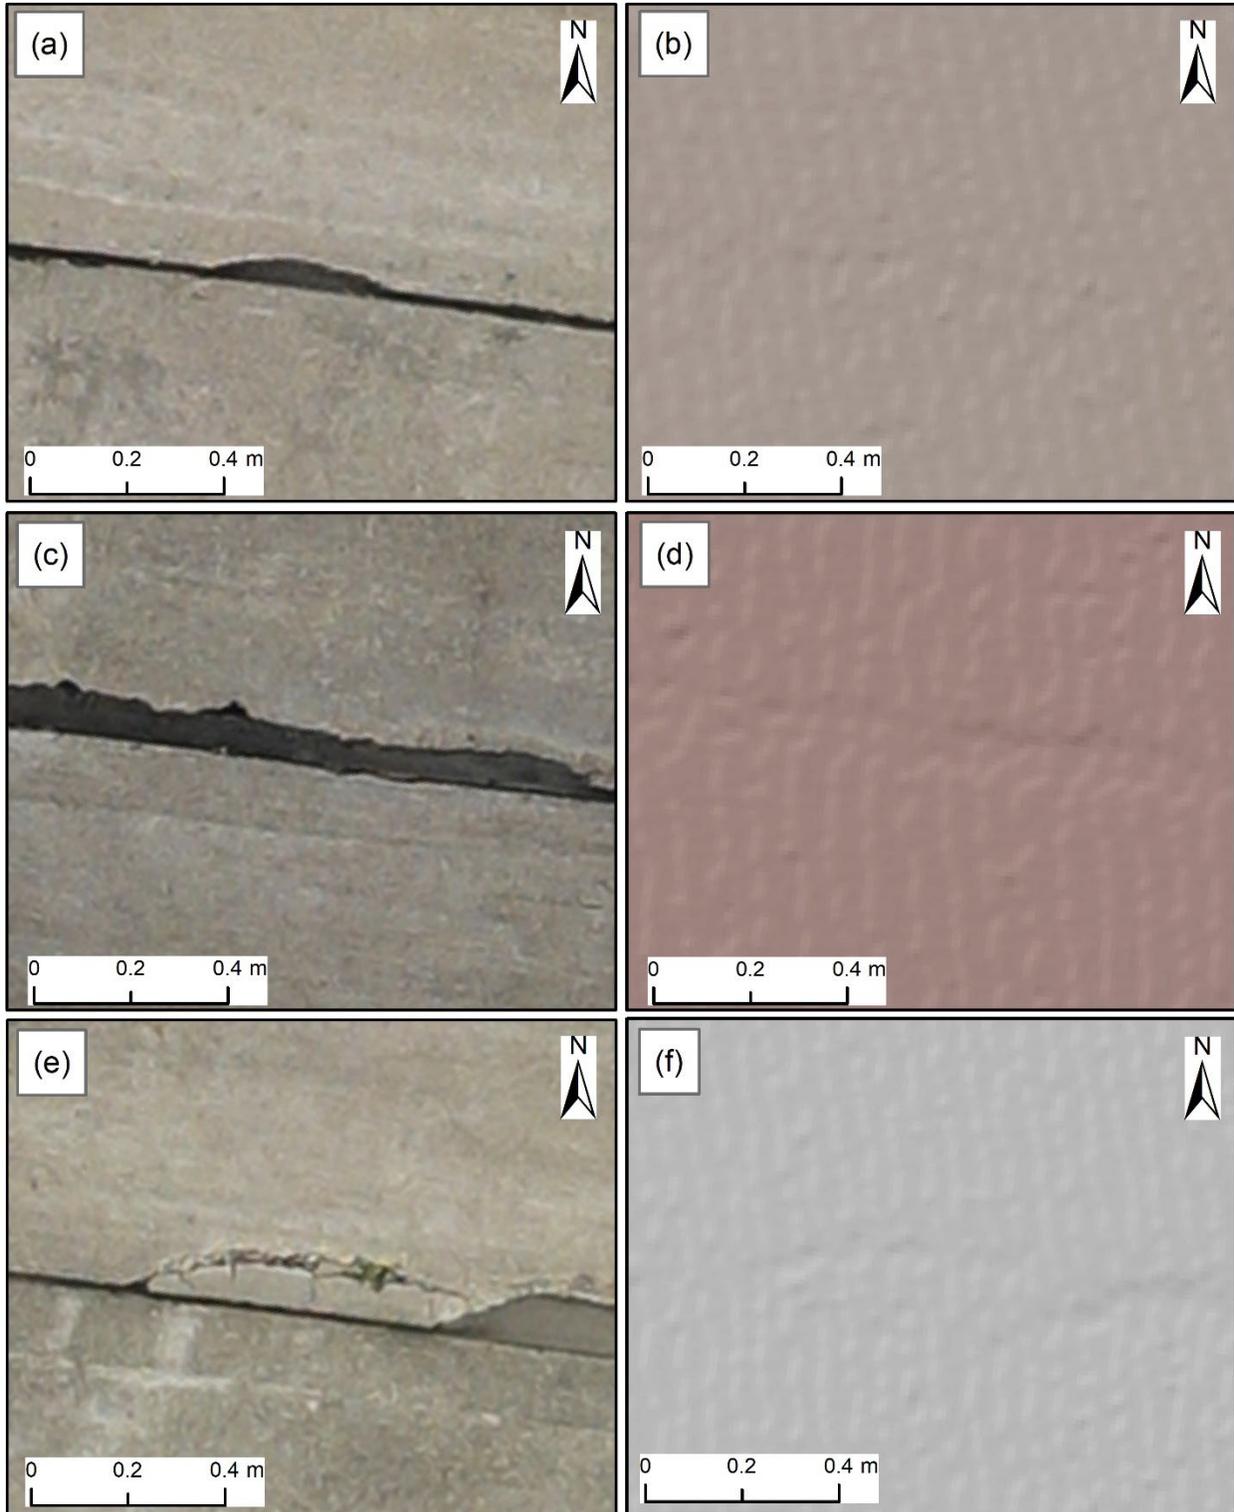
Figure 60. Low-severity Joint Spalling in (a) 2.5-mm/pix Orthophoto and (b) 10-mm/pix DEM; Medium-severity Joint Spalling in (c) 2.5-mm/pix Orthophoto and (d) 10-mm/pix DEM; and High-severity Joint Spalling in (e) 2.5-mm/pix Orthophoto and (f) 10-mm/pix DEM

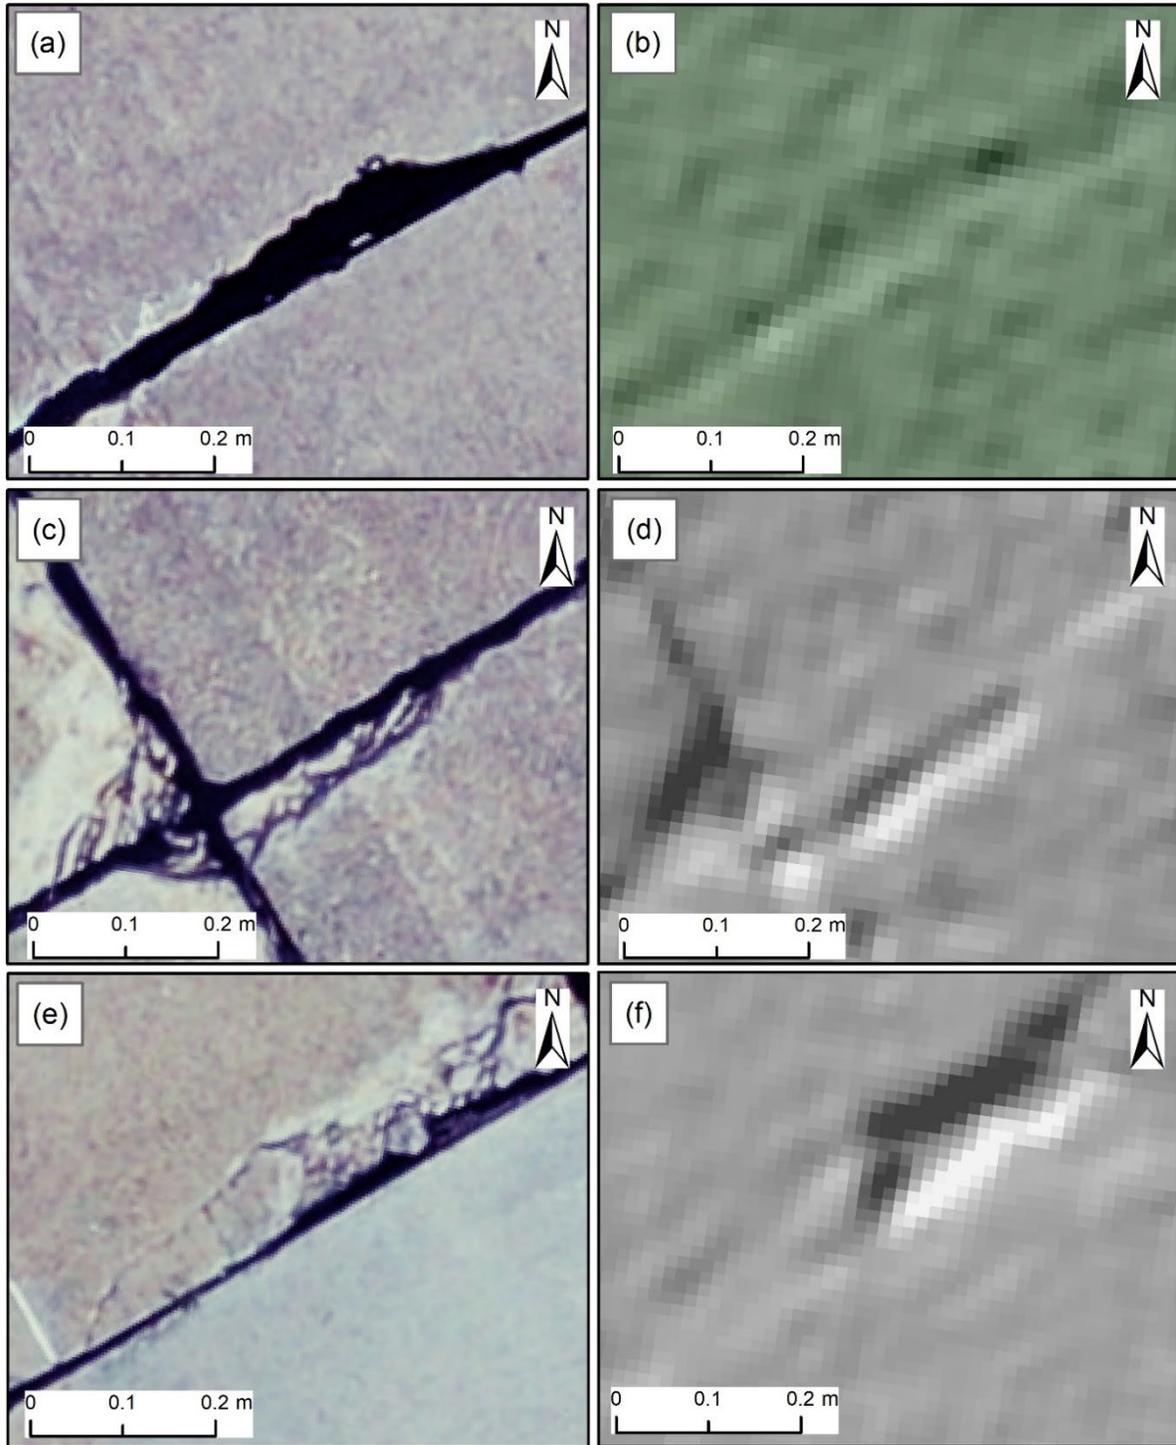
Figure 61. Low-severity Joint Spalling in (a) 3.2-mm/pix Orthophoto and (b) 12.9-mm/pix DEM; Medium-severity Joint Spalling on right and Medium-severity Corner Spalling on left in (c) 3.2-mm/pix Orthophoto and (d) 12.9-mm/pix DEM; and High-severity Joint Spalling in (e) 3.2-mm/pix Orthophoto and (f) 12.9-mm/pix DEM

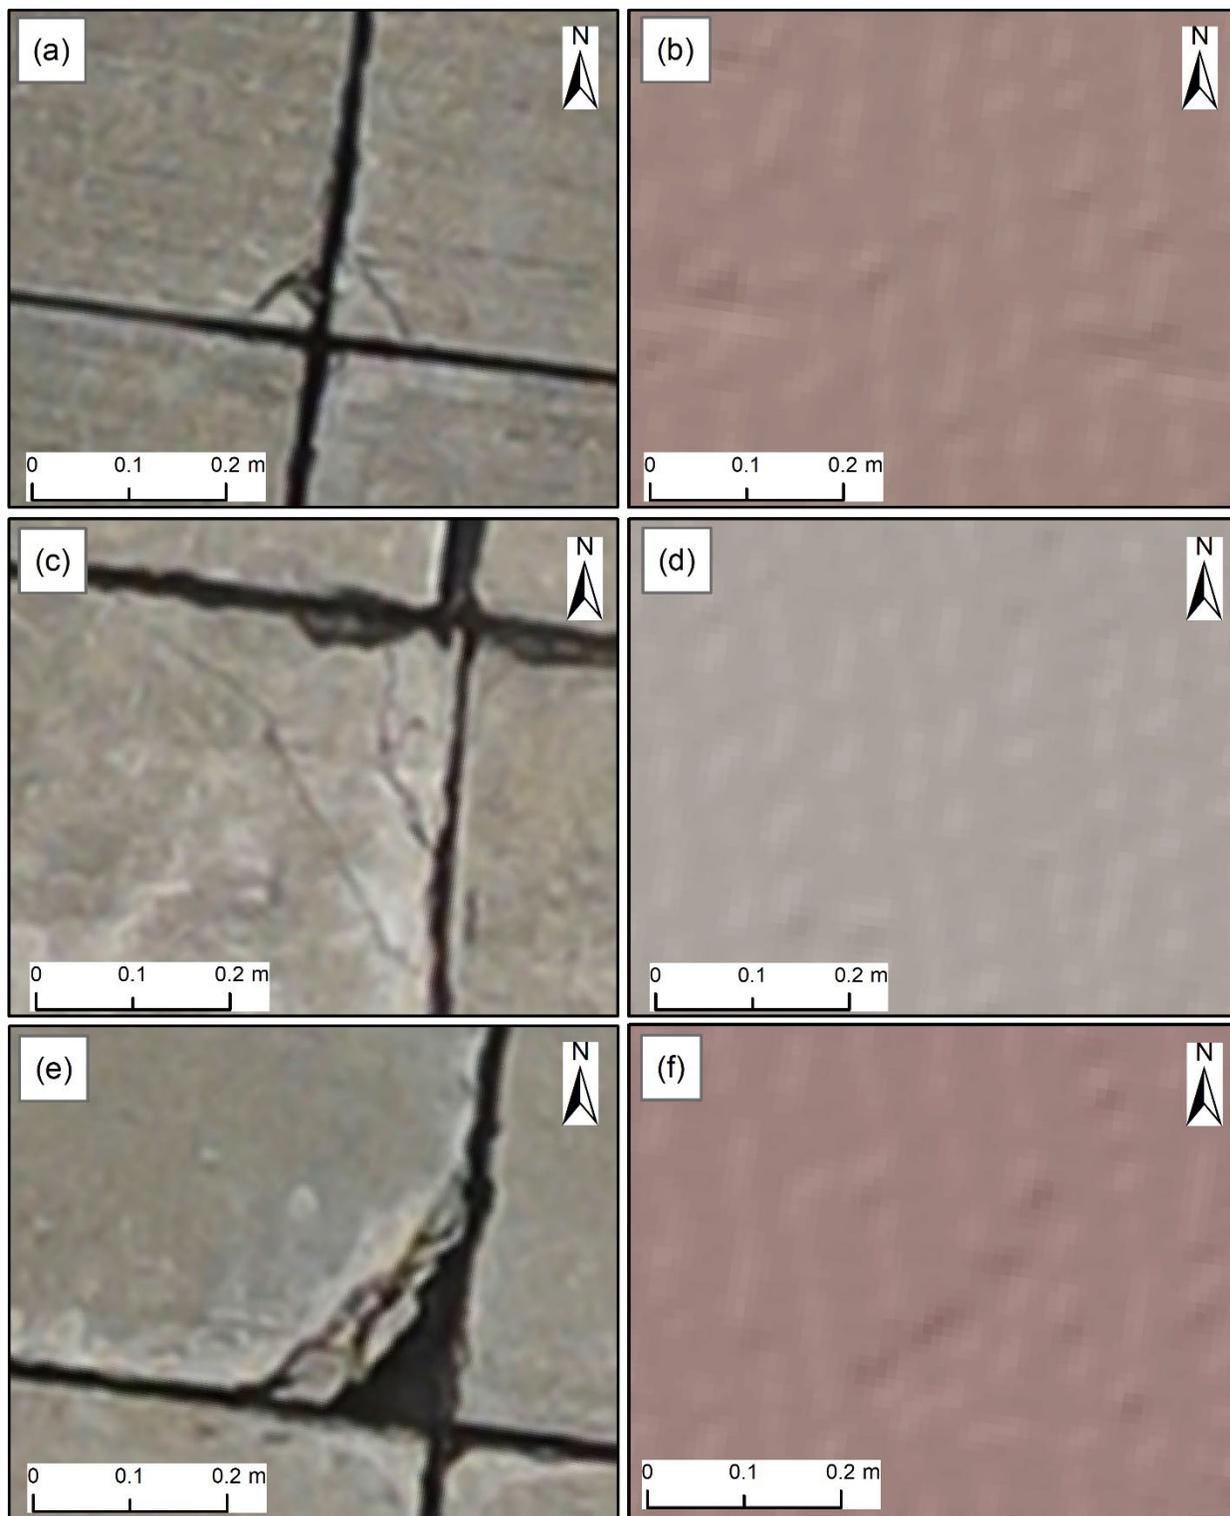
Figure 62. Low-severity Corner Spalling in (a) 2.5-mm/pix Orthophoto and (b) 10-mm/pix DEM; Medium-severity Corner Spalling in (c) 2.5-mm/pix Orthophoto and (d) 10-mm/pix DEM; and High-severity Corner Spalling in (e) 2.5-mm/pix Orthophoto and (f) 10-mm/pix DEM

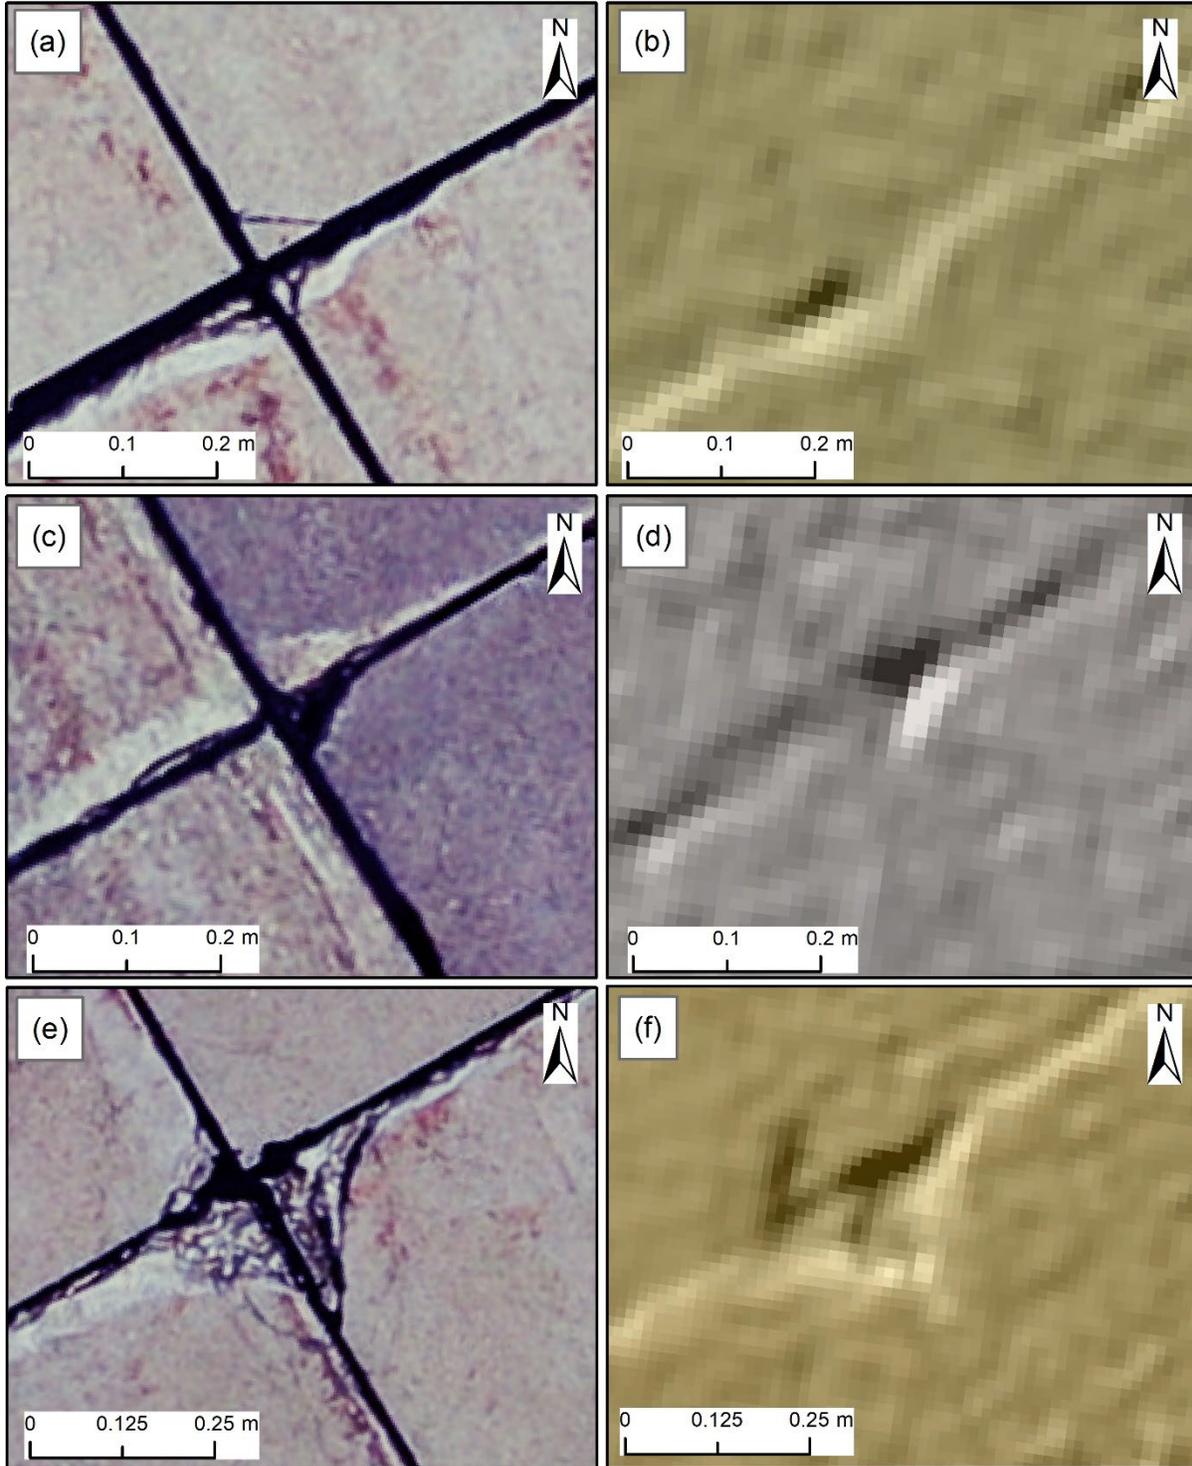
Figure 63. Low-severity Corner Spalling on top and Low-severity ASR on bottom left and bottom right of Joint Intersection in (a) 3.2-mm/pix Orthophoto and (b) 12.9-mm/pix DEM; Medium-severity Corner Spalling on left in (c) 3.2-mm/pix Orthophoto and (d) 12.9-mm/pix DEM; and High-severity ASR in (e) 3.2-mm/pix Orthophoto and (f) 12.9-mm/pix DEM

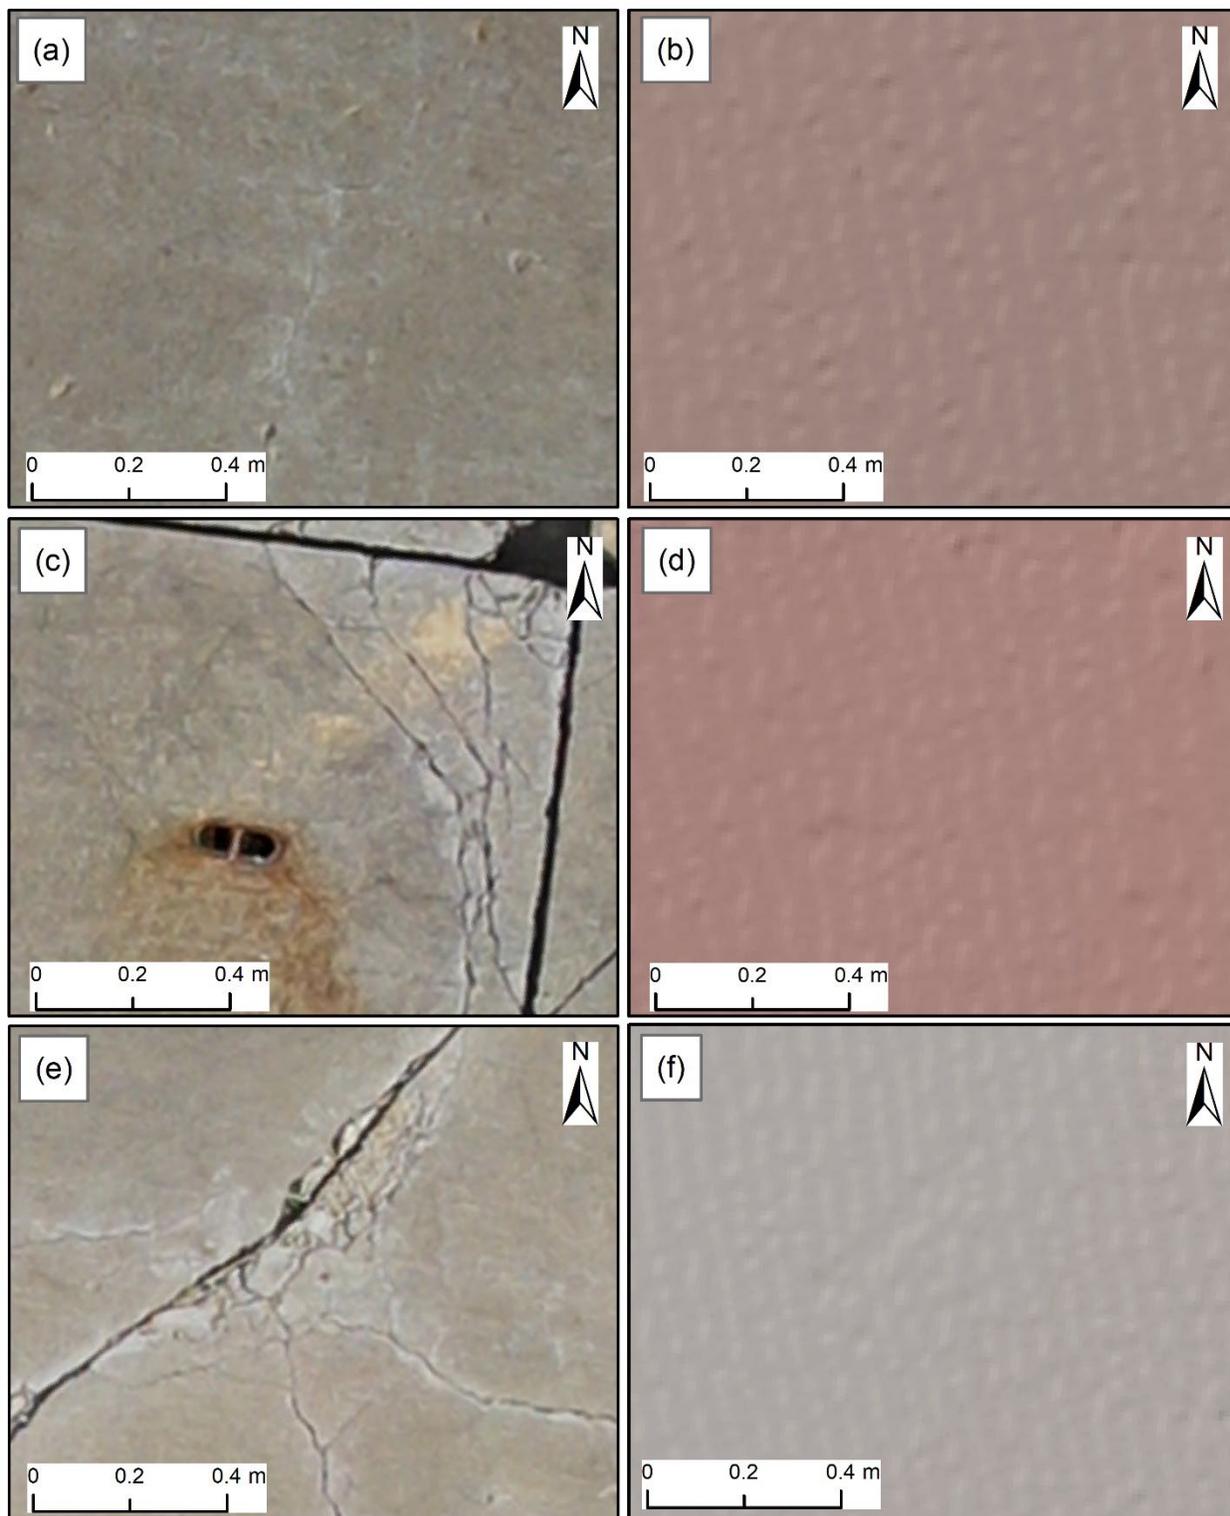
Figure 64. Low-severity ASR in (a) 2.5-mm/pix Orthophoto and (b) 10-mm/pix DEM; Medium-severity ASR in (c) 2.5-mm/pix Orthophoto and (d) 10-mm/pix DEM; and High-severity ASR in (e) 2.5-mm/pix Orthophoto and (f) 10-mm/pix DEM
